Caught in the Act

Proof of Russian Military Intervention in Ukraine

Executive summary¹

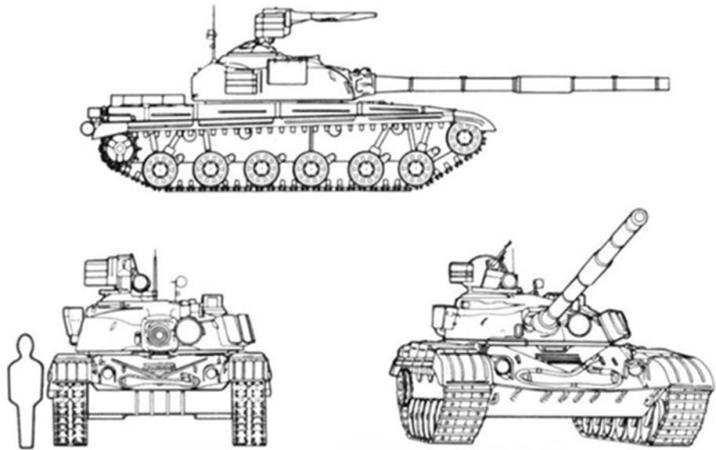
Figure 2 T-64 initial product version²⁸

of the T-64 tank (see Figure 2). The UA also possesses some domestically modified versions of the T-72 tank (see Figure 3). However, all of the T-72s were mothballed and put into reserve depots long before the war started, with many of them being subsequently sold to foreign customers. The first report of the reintroduction of T-72s by the UA is from December 2014, when the UA received a few renovated [T-72A](#) and [T-72UA1](#) units.²⁴ The Ukrainian arms industry, Kharkiv-based Morozov KMDB, offers foreign customers modernisations of T-72 tanks, for example, the [T-72AG](#).²⁵

²⁹ Source: Gary's Combat Vehicle Reference Guide, 'T-72 Main Battle Tank', 18 May 2008, accessed at <http://www.inetres.com/gp/military/cv/tank/T-72.html> on 1 July 2015. Note: Drawings of the basic versions of the T-64 and T-72. The most distinct difference is the chassis.

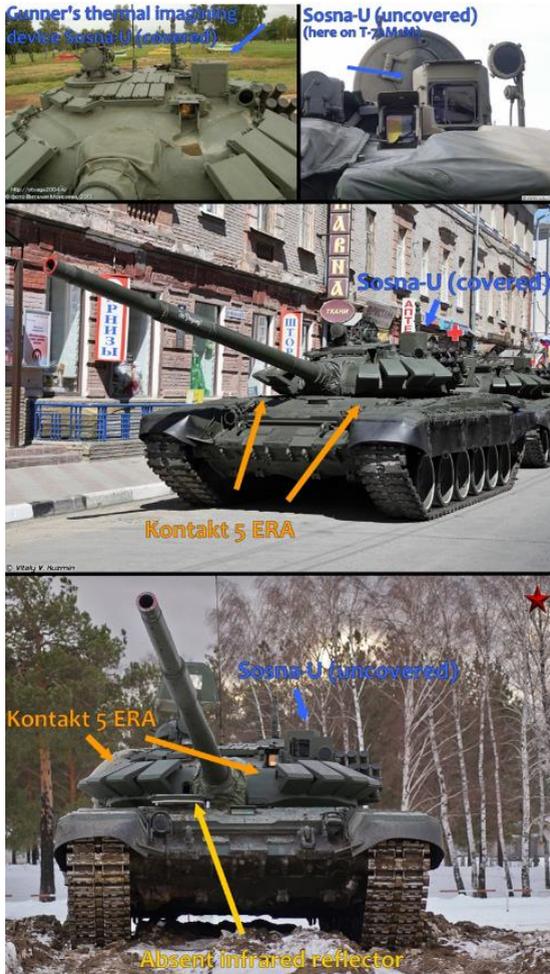
Figure 4 T-72B3, detail³⁰

This tank has been videoed in the Donbass several times since August 2014 and has become a point of interest for experts on military hardware³¹ because it is one of the most modern tanks in the RA. It utilises the Sosna-U, a gunner's thermal imaging device which supersedes the Luna infrared reflector, and is equipped with Kontakt 5 ERA.³² Thanks to these characteristics it is easily distinguishable from all of the older T-72s.

³⁰ Sources: (from upper left) *otvaga2004.ru*, 'Показ Боевой Техники В Алабино. Танк Т-7263 – Фотодетализация', <http://otvaga2004.ru/tanki/tanki-fotogalereya/alabino-tank-t-72b3/>; *TankTech.Wordpress.com*, 'Sosna-U', <https://tanktech.wordpress.com/2009/07/09/sosna-u/>; V. V. Kuzmin, 'Парад Победы 2014 в Нижнем Новгороде (2014 Victory Day Parade in Nizhny Novgorod)', <http://vitalykuzmin.net/?q=node/563>. For the last-mentioned item, we were not able to find the link to the original source. However, the red star symbol indicates that it is a picture from footage by TV Zvezda (<http://tvzvezda.ru/>). The symbol was modified at the beginning of 2015.
